## Appendix C: Existing Conditions Field Survey

# PUTNAM COUNTY RAIL LINK

## Field Study of Areas of Potential Environmental Significance

**KC ENGINEERING**  
**FEASABILITY REPORT**  
**INSPECTION DATE: SEPTEMBER 30, 2021**

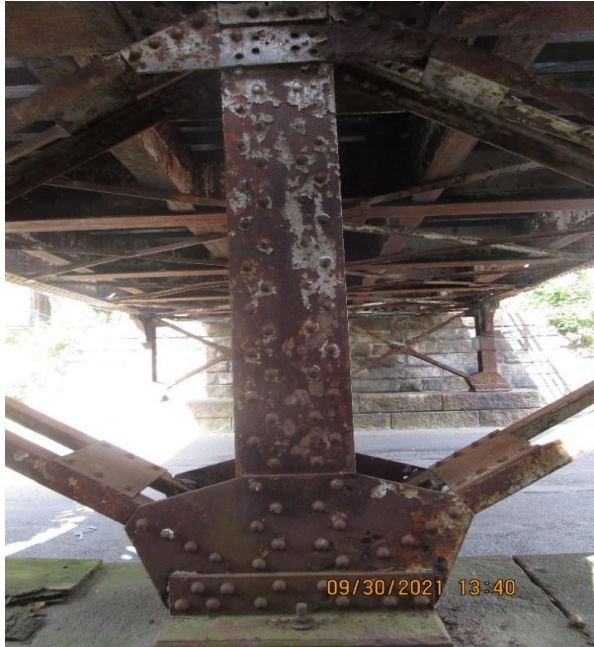
Under the middle pier looking north  
towards the corroded truss

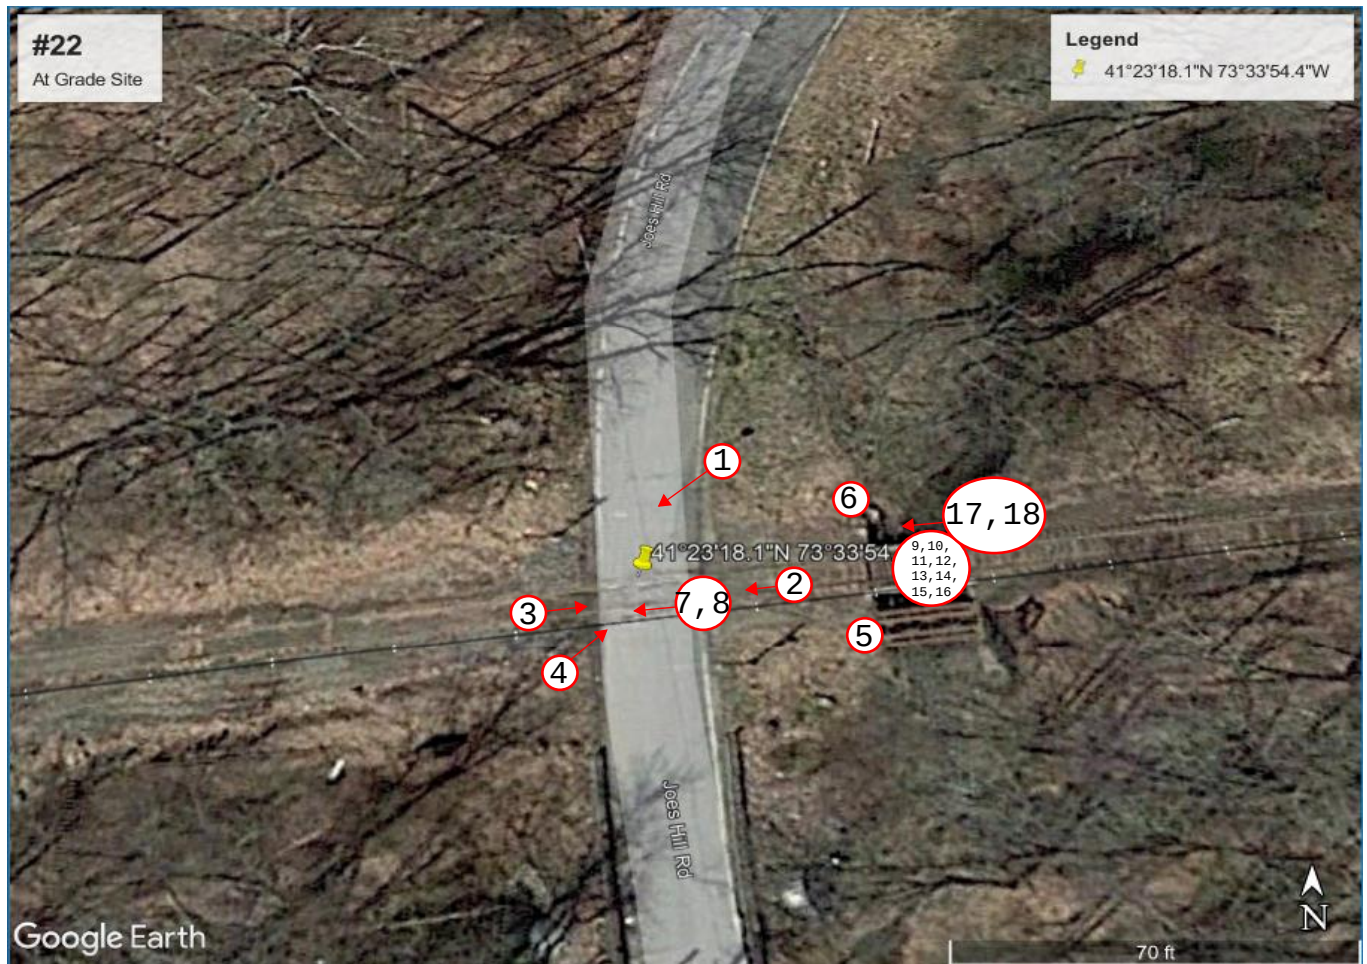
Pavement at intersection rutted  
 Small potholes around corner  
 Photo (9-17) taken underneath bridge or at N-W corner of bridge  
 2 I-beam girders 17'-3" long  
 Diagonal angle bracing  
 3 I-beam diaphragms

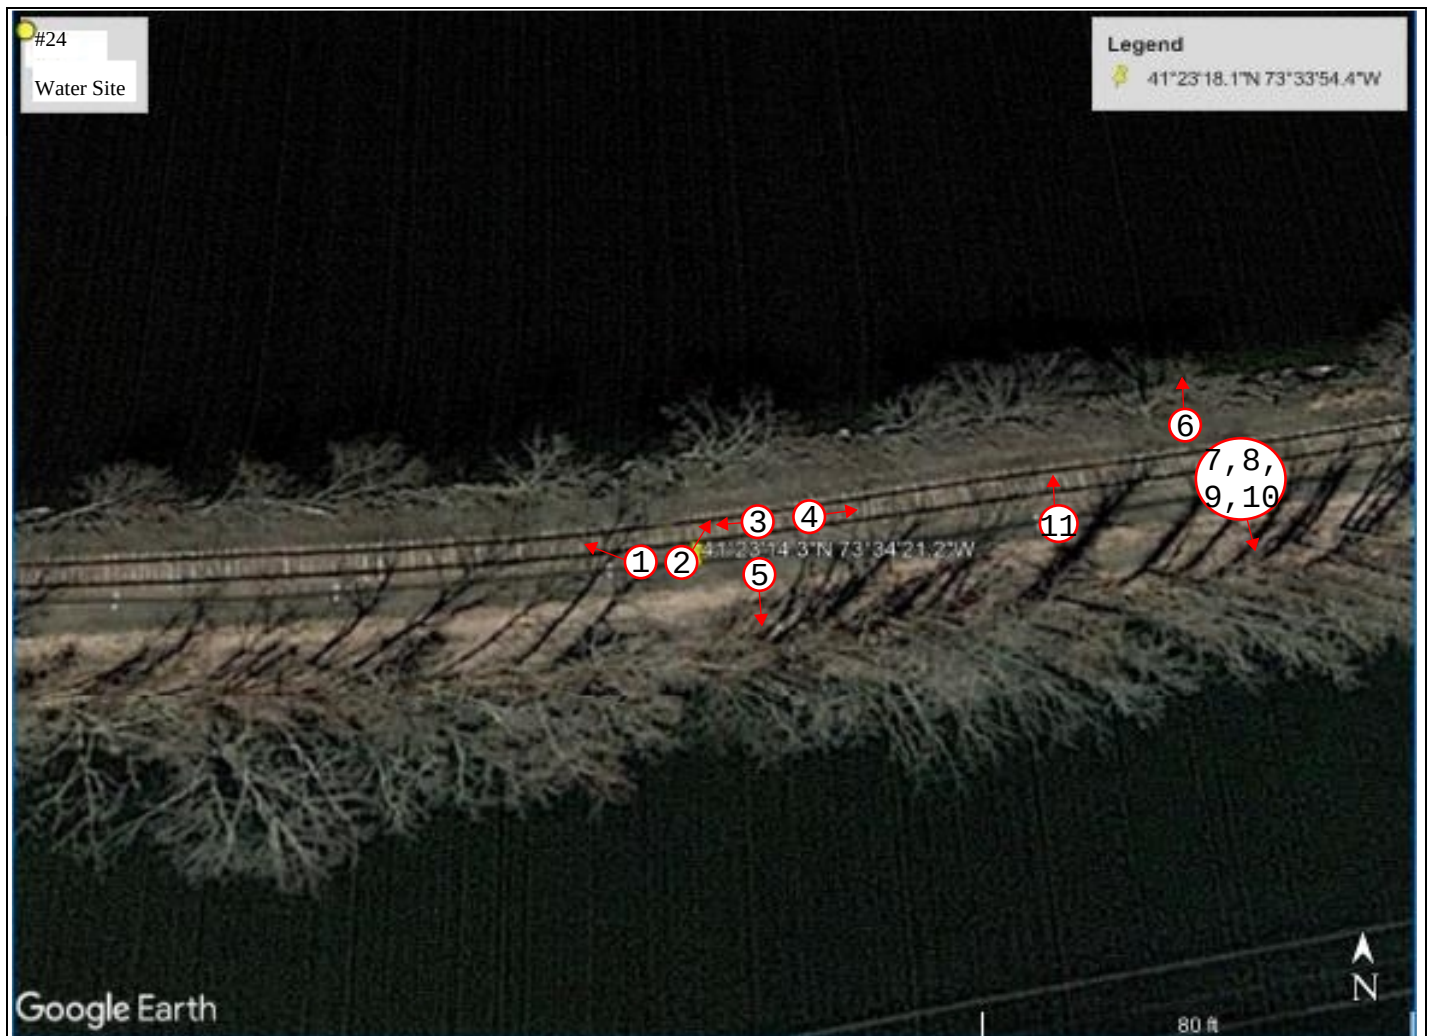
New bike lane parallel south of railroad tracks

Powerlines shown on photo 6 seem to be hanging relatively low

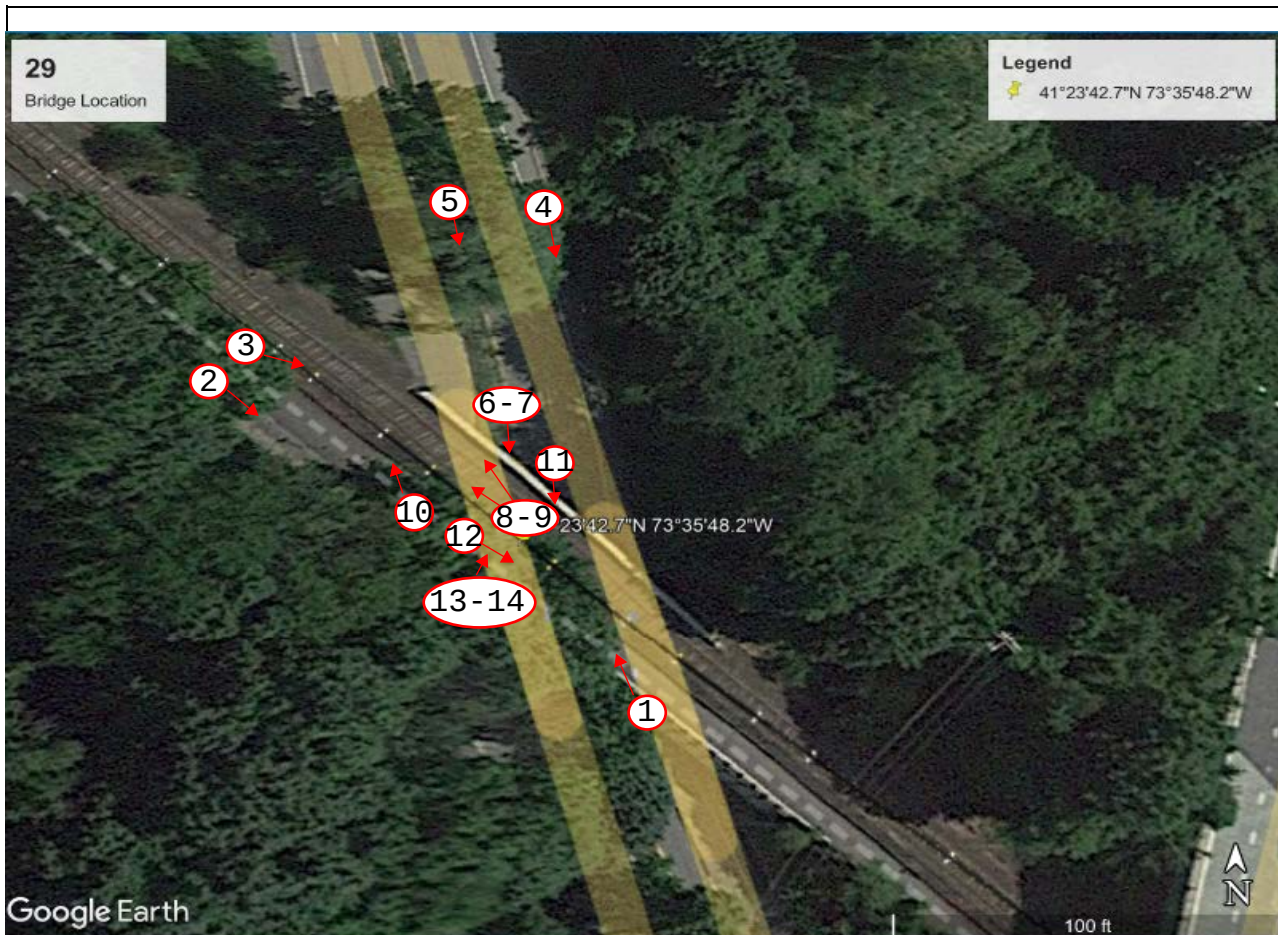
- 6-7 at same location.(6 - Looking at column,  
7 - Looking at base of column)
- 8-9 at same location.(8 - Looking at N-W bridge underdeck  
9 - Looking at West face abutment)
- 11 - Location under bridge looking South at column pier
- 13-14 Same location looking N-E towards bridge with different slightly different angle

North middle pier shows signs of concrete spalling near base  
Girders show signs of rust and corrosion

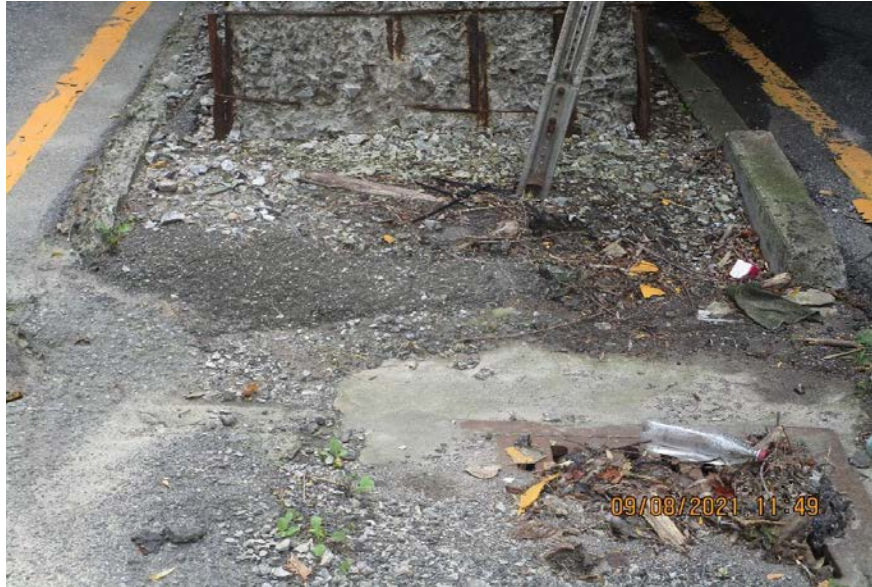
*Attachment Description:*  
From north of the bridge, at  
the center pier looking at the  
concrete spalling
